Manhole Inspection Summary

Manhole # S41W1_011MH

Insp Date: **8/14/08 9:21 AM**

Location Address: **617 Annabel**

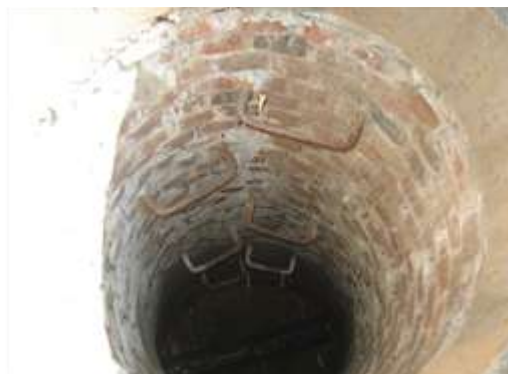
Count: **7** Missing: **0** ☒ **Corroded**

steps

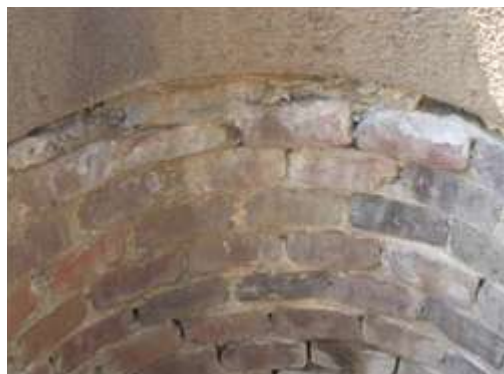
Defect 1

Condition: ☐ Sound ☐ Cracked ☐ Root Intrusion ☒ **Loose Brick** ☐ Deteriorated

Infiltration: ☐ None ☐ Joint ☒ **Cracks** ☐ Mortar ☐ Roots ☐ Wall

loose Bricks in Chimney

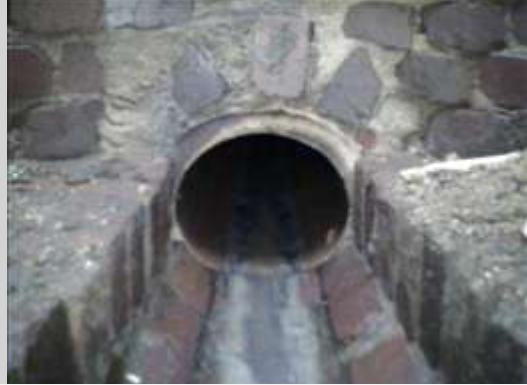
12 O'Clock Outflow

8 in. Circular Gravity Sewer
Pipe Out @ 12 O'Clock

Pipe Height: **8.4** (in.) Rod and Bar (Angled)
Pipe Material: **Clay** ☐ Pipe Lined
Invert Depth: **12.26** (ft.) Flow Characteristics: **Slow**
Deposits: ☒ None ☐ Mud ☐ Sludge ☐ Debris ☐ Grease
Silt Depth: (in.) Deposits Extent:
Infiltration: **None** Pipe Seal Cond: **Sound**

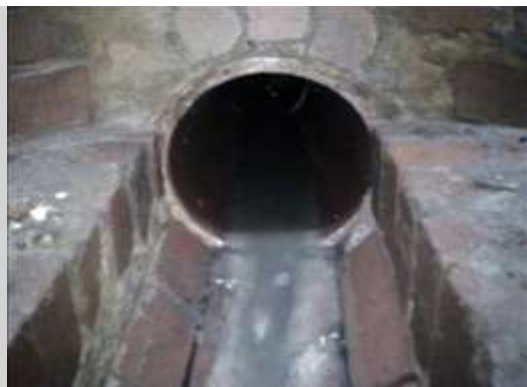
6 O'Clock Inflow

8 in. Circular Gravity Sewer
Pipe In @ 6 O'Clock

Pipe Height: **8.4** (in.) Rod and Bar (Angled)
Pipe Material: **Clay** ☐ Pipe Lined
Invert Depth: **11.86** (ft.) Flow Characteristics: **Slow**
Deposits: ☒ None ☐ Mud ☐ Sludge ☐ Debris ☐ Grease
Silt Depth: (in.) Deposits Extent:
Infiltration: **None** Pipe Seal Cond: **Sound**
